SCREENING LEVEL RISK ASSESSMENT (SLRA)

Case Study

Case Study 1 – Maxhamish Field

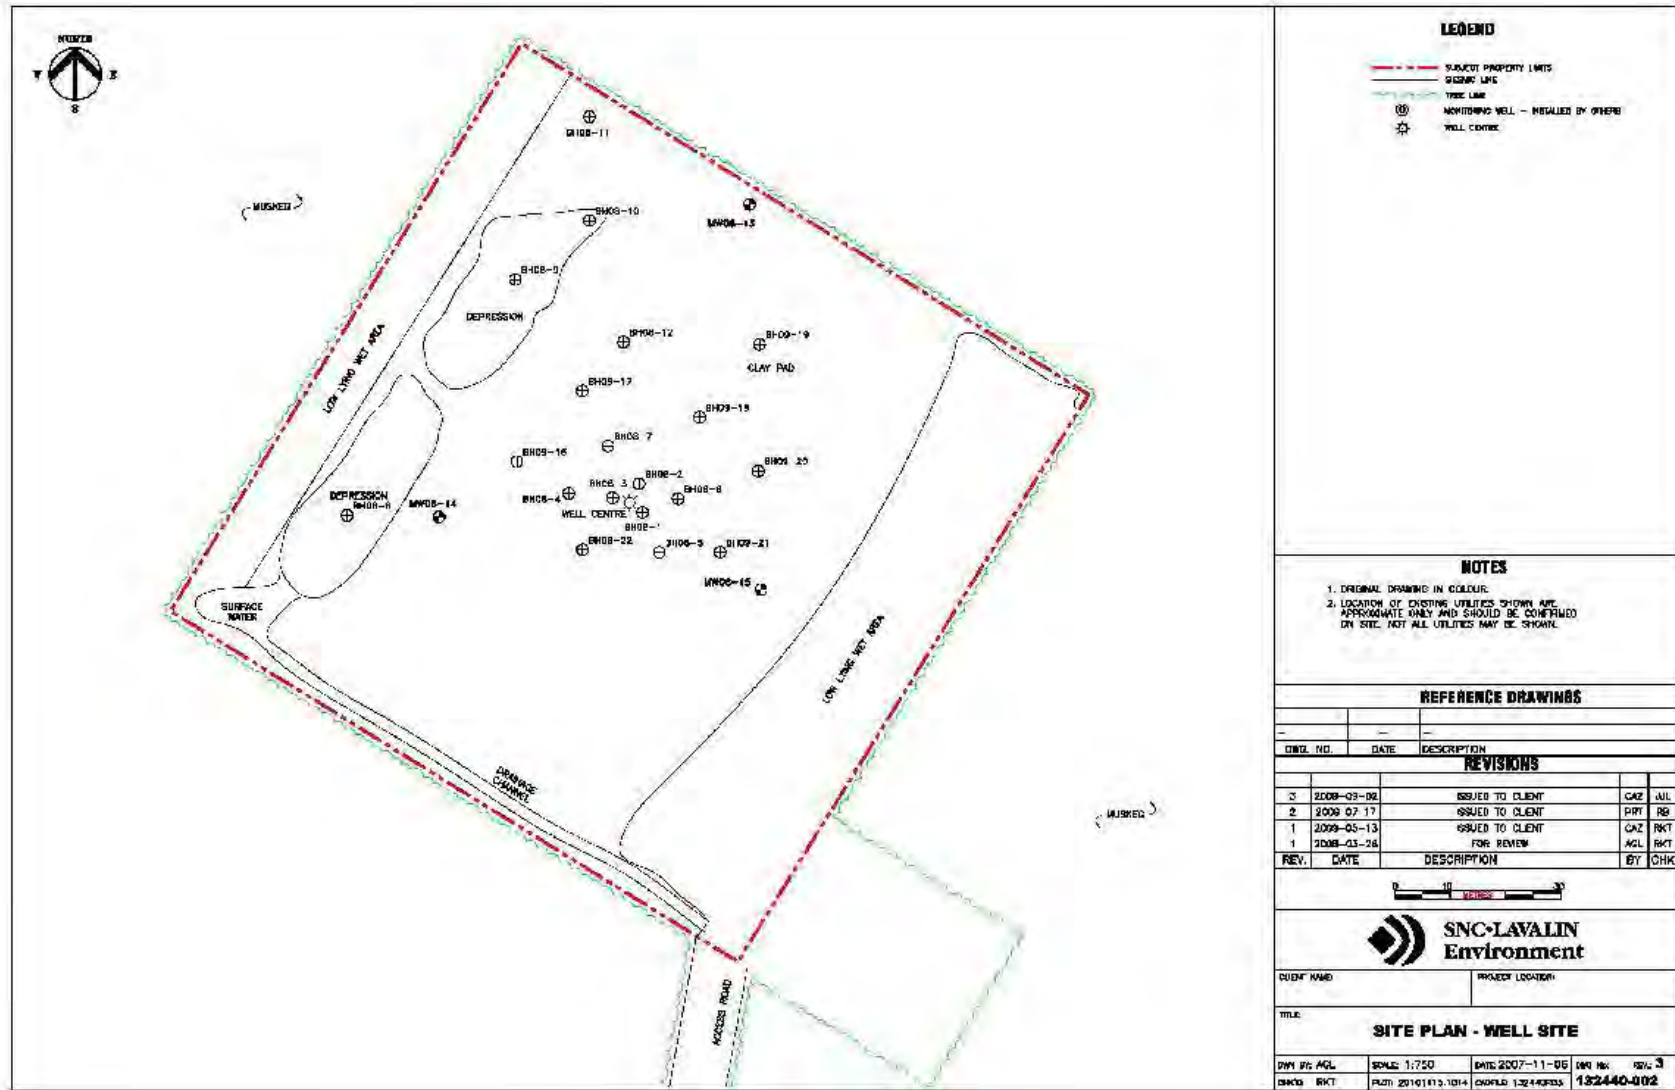
Site Plan

- ◆ Well Center
- ◆ Sump
- ◆ Depressions
- ◆ Background
- ◆ PCoCs – petroleum hydrocarbons (BTEX / VPH, EPH, PAH), metals, salinity (Na, Cl)
